RE: Asbestos Inspection at 600 and 602 Boulevard
600 and 602 Boulevard, Colonial Heights, Virginia
EEE Project 09-075

Inspection for Asbestos-Containing Materials (ACM)

Colonial Heights, Virginia

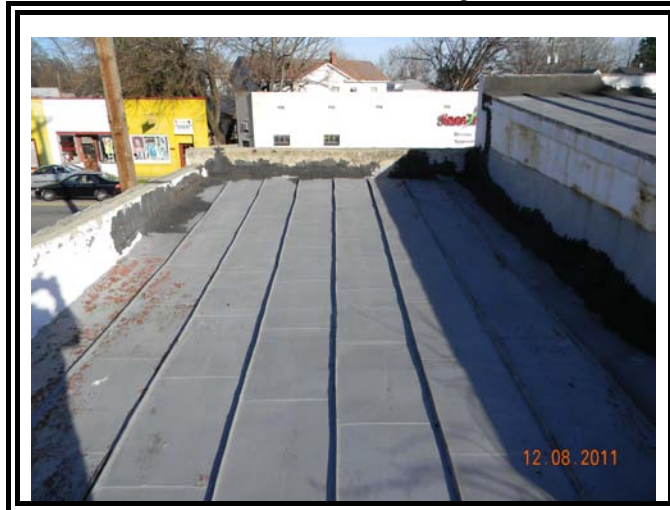
The exterior black roofing tar on 600 Boulevard building contains asbestos. All of the black roofing tar should be assumed to contain asbestos. Appendix A, photograph 2, shows a photograph of the observed material. There is approximately 180 square feet of this material located on the roof. The roofing tar is considered Category I, Non-Friable ACM.

Photograph No. 2. View of 600 Boulevard roof with black roofing tar positive for asbestos.

Since all the ACM identified in building 600 is Category I ACM, EEE recommends Option 1 for building 600.

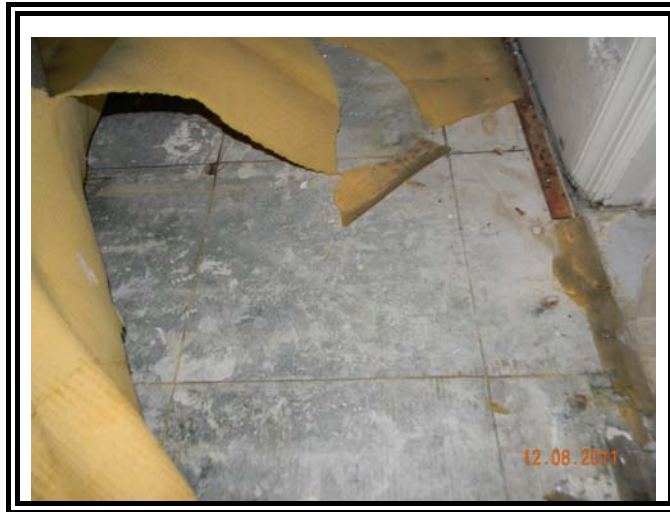
The 12" X 12" tan VFT and associated black mastic of 602 Boulevard house contains asbestos. The tile and mastic was observed in the 1st floor back bedroom underneath the carpet. Appendix A, photograph 4, shows a photograph of the observed material. There is approximately 40 square feet of this material located in this room, which is classified as Category I, Non-Friable ACM.

Photograph No. 4. View of 12" X 12" tan VFT with associated black mastic both positive for asbestos located in the back bedroom on the 1st floor of 602 Boulevard house.

Building 602 has mostly Category 1 ACM but also has a small amount of Category II ACM. Therefore, for building 602, EEE recommends either Option 1 or 2.

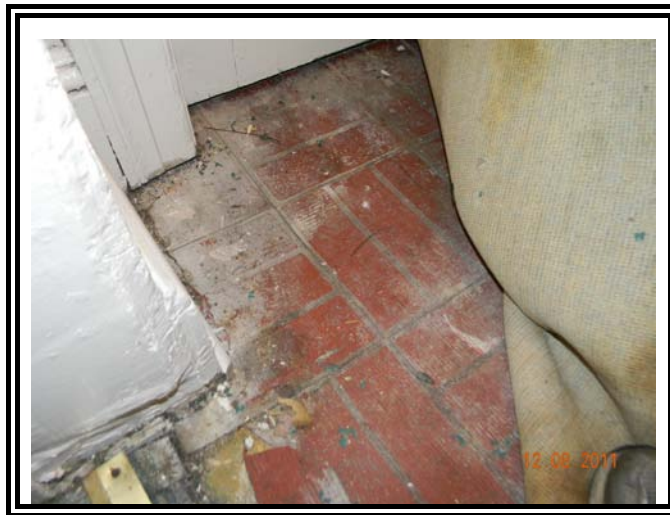
The 9" X 9" brown VFT of 602 Boulevard house contains asbestos. The tile was observed in the 1st floor bathroom underneath the carpet. Appendix A, photograph 5, shows a photograph of the observed material. There is approximately 20 square feet of this material located in this room, which is classified as Category I, Non-Friable ACM.

Photograph No. 5. View of 9" X 9" brown VFT positive for asbestos located in the bathroom on the 1st floor of 602 Boulevard house.

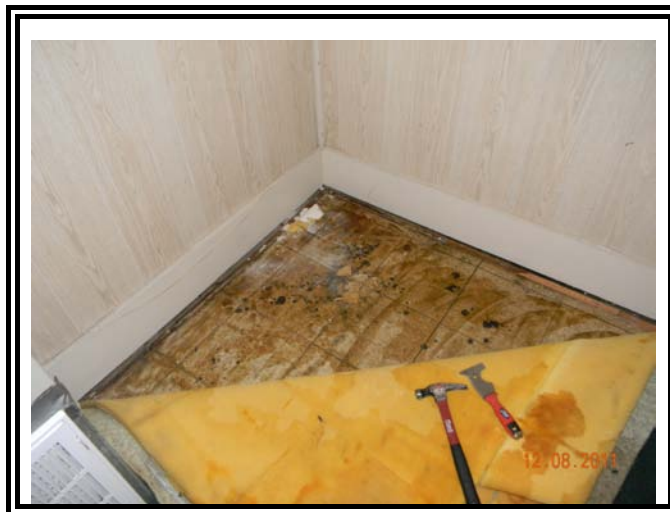
The 12" X 12" tan VFT of 602 Boulevard house contains asbestos. The tile was observed in the front office, formerly Data Pool, throughout the entire room underneath the carpet. Appendix A, photograph 6, shows a photograph of the observed material. There is

approximately 600 square feet of this material located in this room, which is classified as Category I, Non-Friable ACM.

Photograph No. 6. View of 12" X 12" tan VFT positive for asbestos located in the former Data Pool room of 602 Boulevard house.

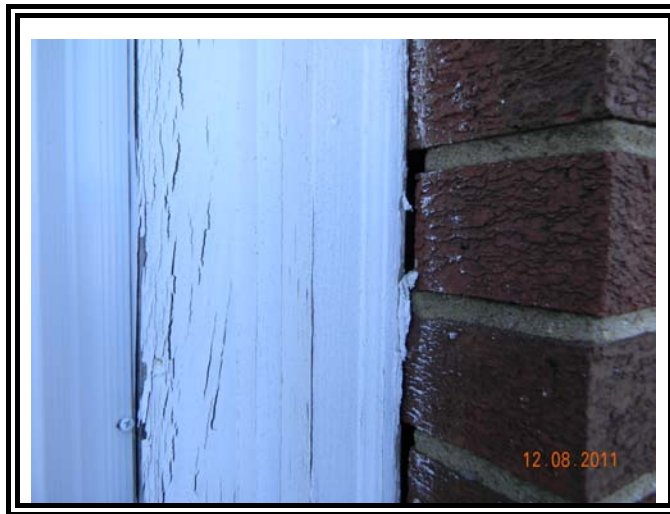
The exterior white caulking around red the brick of 602 Boulevard house between the wooden window trim and red brick contains asbestos. All of the caulking around the red brick and wood trim of the first floor of the exterior, including windows, doors and ends; have this same kind of caulking present. Appendix A, photograph 7, shows a photograph of the observed material. There is approximately 100 linear feet of this material located on the exterior of the house with the wooden trim and red brick, which is classified as Category II, Non-Friable ACM.

Photograph No. 7. View of exterior white window caulking positive for asbestos between the wooden trim and red brick located at 602 Boulevard house.

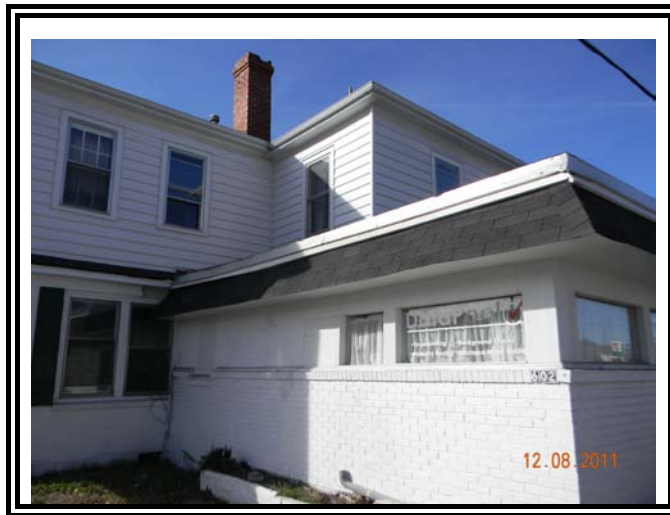
The black chimney flashing tar of 602 Boulevard house contains asbestos. The tar was observed around the chimney between the metal flashing, the brick and asphalt shingles. Appendix A, photograph 8, shows a photograph of the chimney. There is approximately 10 square feet of this material located around the chimney, which is classified as Category I, Non-Friable ACM.

Photograph No. 8. View of chimney at 602 Boulevard house with black chimney flashing tar positive for asbestos.
